FIELD INSPECTION

Project Name:	Mountain Valley Pipeline	Inspector:	Matthew Grant
Inspection Date:	Tuesday, March 5, 2019	Project Contact:	Brian Clauto
Spread: Pittsylvania County MP 299-300 St#15838-15865 MP285 St#15084-15092 MP270 St#15055+88	Spread I	Weather (Wet/Dry/Rain):	Wet

FIELD INSPECTION PHOTO LOG

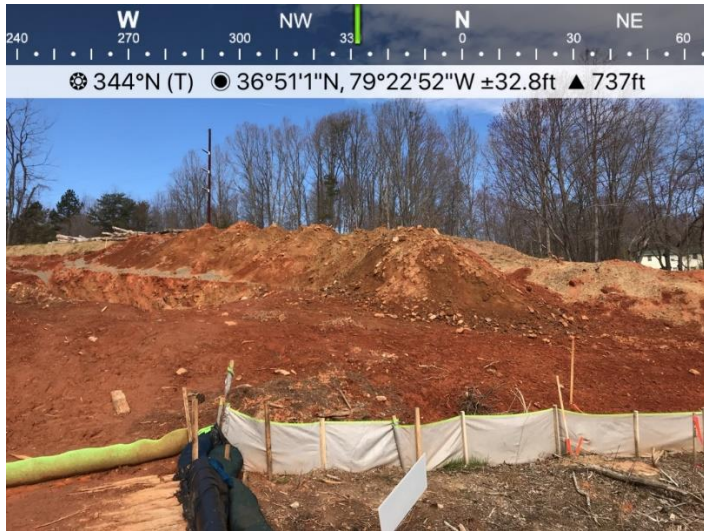
- Fig. 1 St#15850+56 stockpile lacks stabilization

Recommended Corrective Action: Maintain all controls per the approved plan and specs, remove sediment and stabilize per DEQ approval.

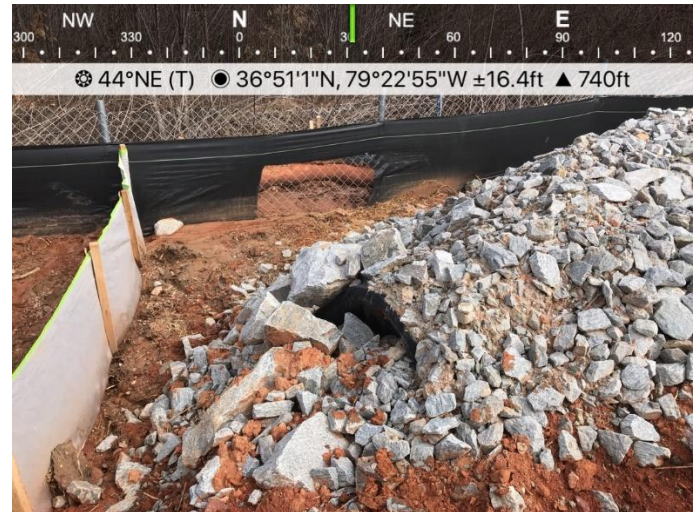
- Fig. 2 St#15865+00 level spreader lacks end cap

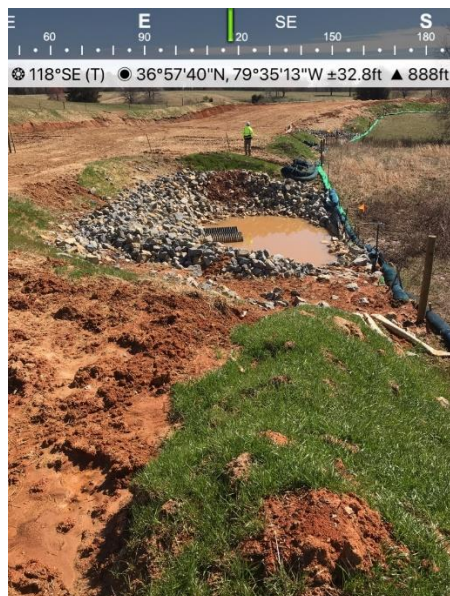
- Fig. 3 St#15084+00 CWD has been breached

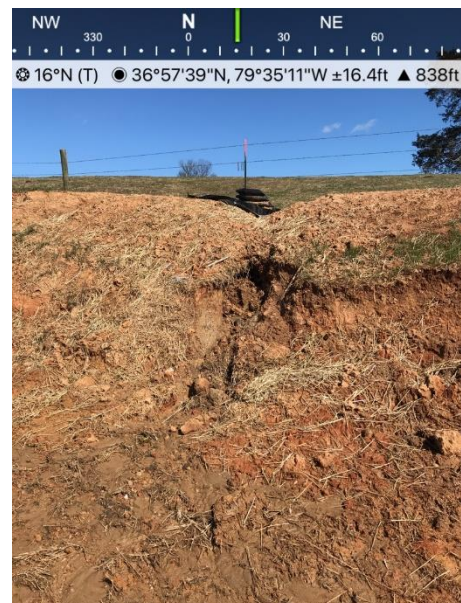
- Fig. 4 St#15086+00 CWD inlet has eroded

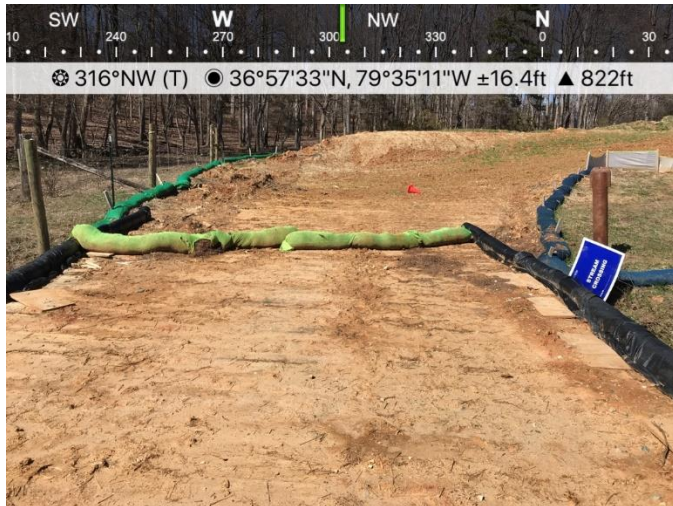
- Fig. 5 St#15092+95 CFS waddle is torn

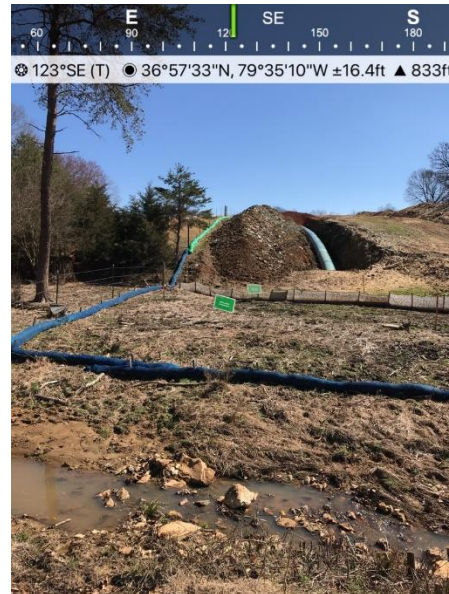
- Fig. 6 St#15093+75 stockpile lacks stabilization

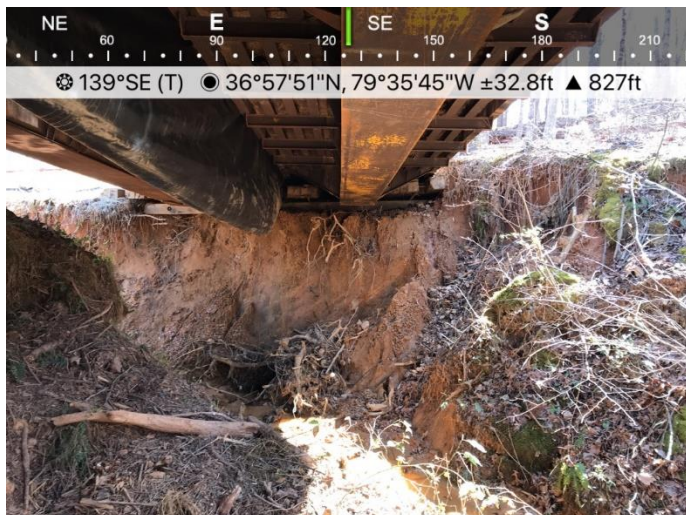
- Fig. 7 St#15055+88 at S-D1-EPH stream bank has eroded from and sediment has entered the stream
